Using LiDAR to Performing Dam Breach Inundation Studies

Missouri GIS Advisory Committee's

Advanced LiDAR Workshop

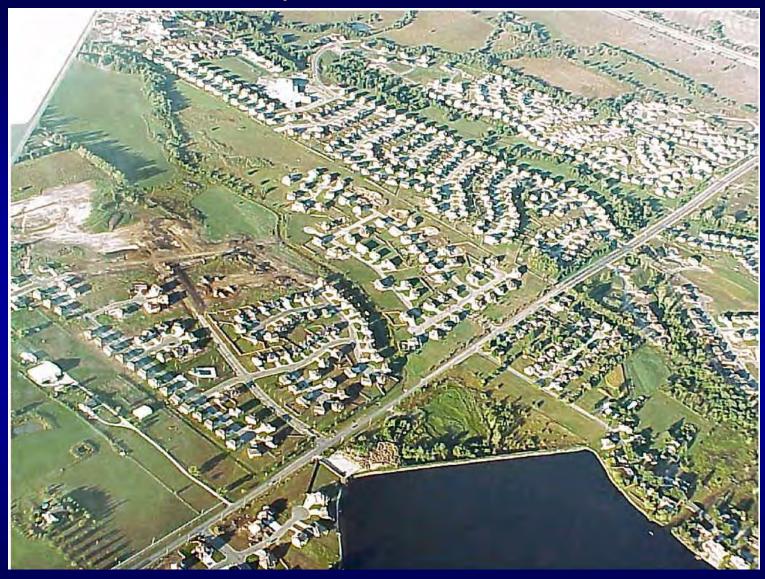
Silverlake Enterprizes Dam MO20051

Height: 30 ft

Storage: 851 ac-ft

near Raymore, Cass County

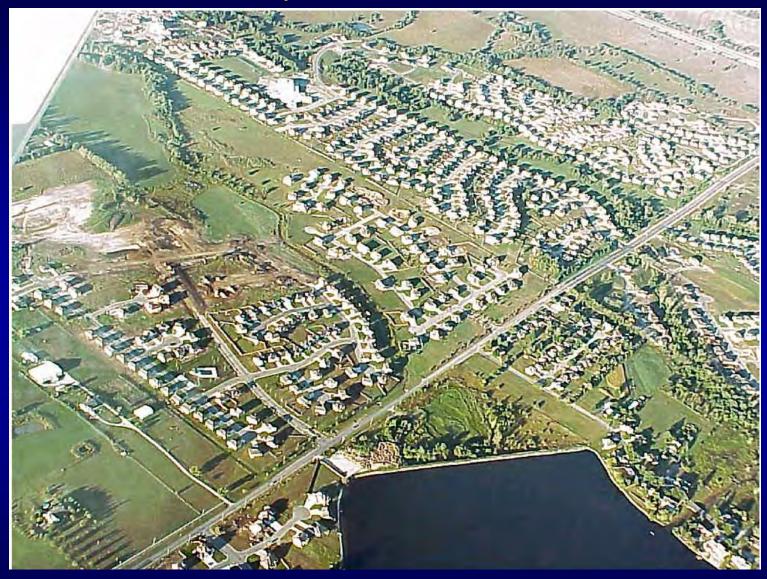
Silverlake Enterprizes Dam MO20051

Height: 30 ft

Storage: 851 ac-ft

near Raymore, Cass County

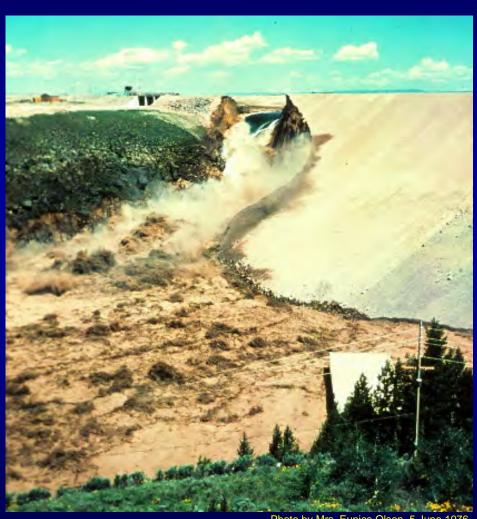
Dam Breach Characteristics

- Rapid release of water
- Surging wave traveling downstream
- Includes debris
- Generally exceeds normal flood elevation

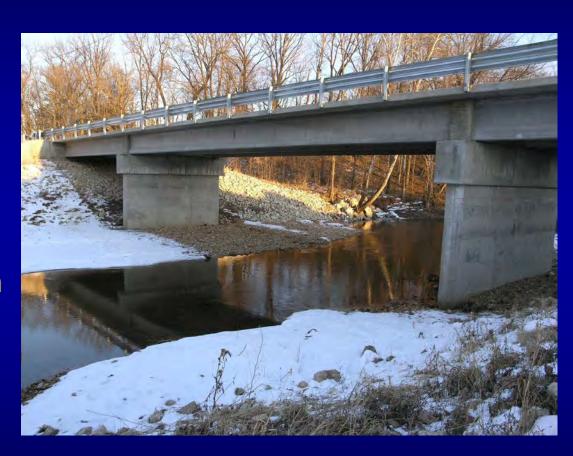
Field Work

- Type of structure
- Deck width
- Deck length
- Headwall location and orientation
- Total chord depth
- Pier size and location (bridge only)
- Length (culvert only)
